## **Dendrochronological dates for the Crailo House, Rensselaer, NY**

Carol Griggs  
Cornell Tree-Ring Lab, Cornell University, Ithaca, NY 14853  
cbg4@cornell.edu

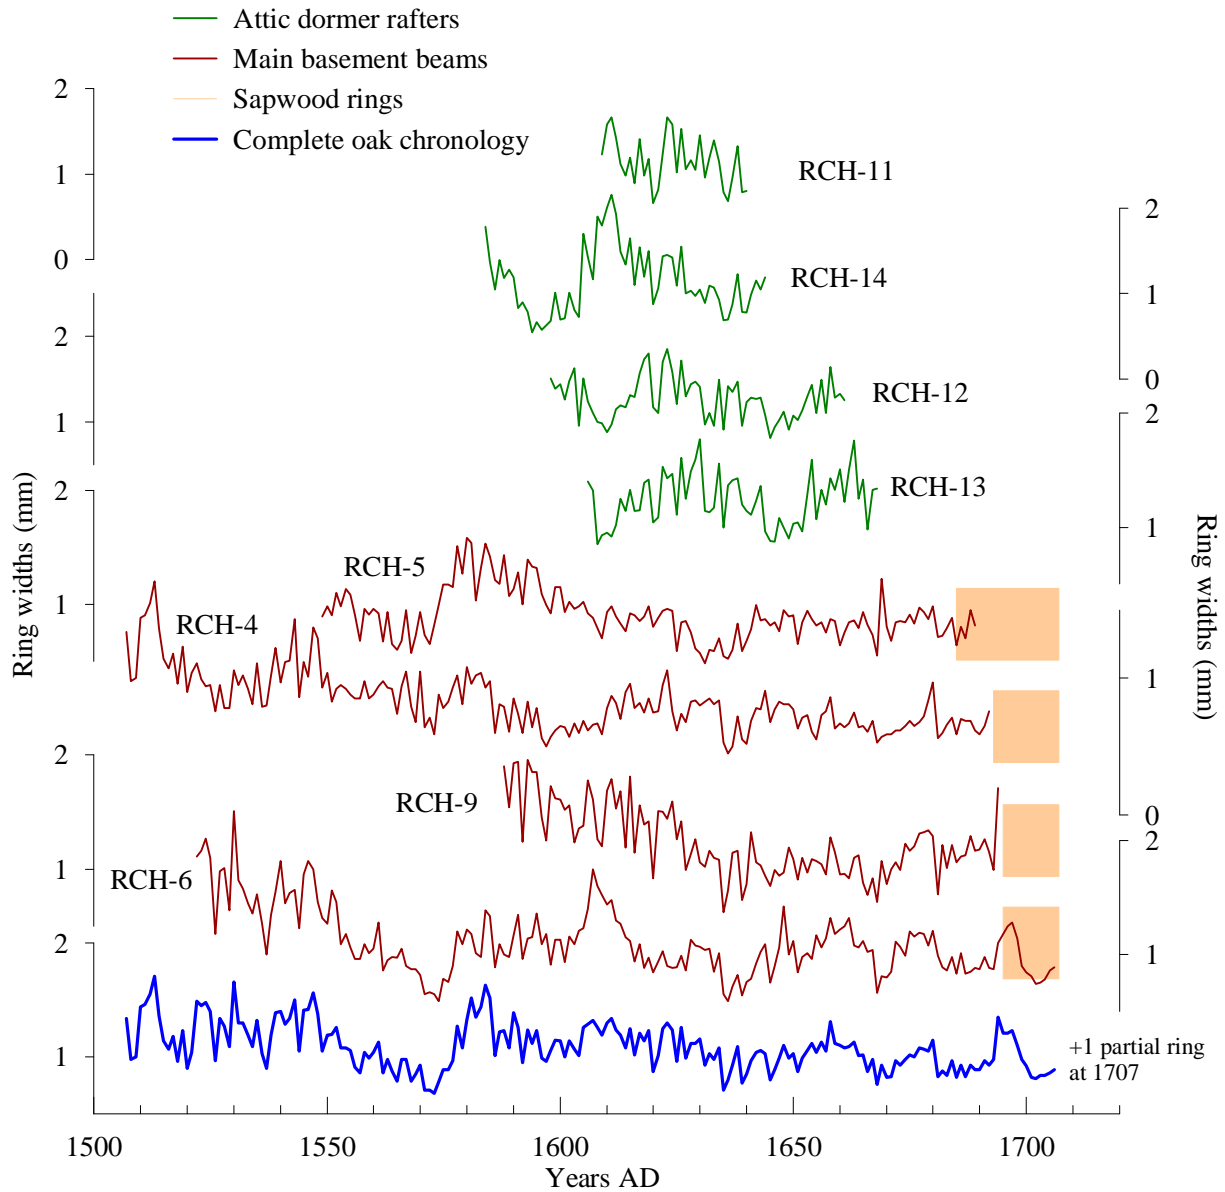
Figure 1. The raw measurements of the oak samples collected from the Crailo House.

The Crailo oak chronology is built of samples RCH-4, 5, 6, and 9 from the main basement, and RCH-11 & 14 and 12 & 13 from squared support beams in the attic window frames (Figure 1). The chronology covers 200 years in time. There are additional, incomplete, outermost sapwood rings in two samples from the main basement, which indicate that the trees were felled during the growing season, most likely May to June of that year. The house would have been constructed soon after the felling, most likely in the summer months.

Main basement beams:

- RCH-5: lintel above fireplace
- RCH-4: fireplace cradle beam
- RCH-9: lintel above doorway to boiler room
- RCH-6: fireplace cradle beam

Attic dormer roof rafters:

- RCH-11, 12, 13, and 14.
- All were squared and had been burnt.
- None contain any sapwood.

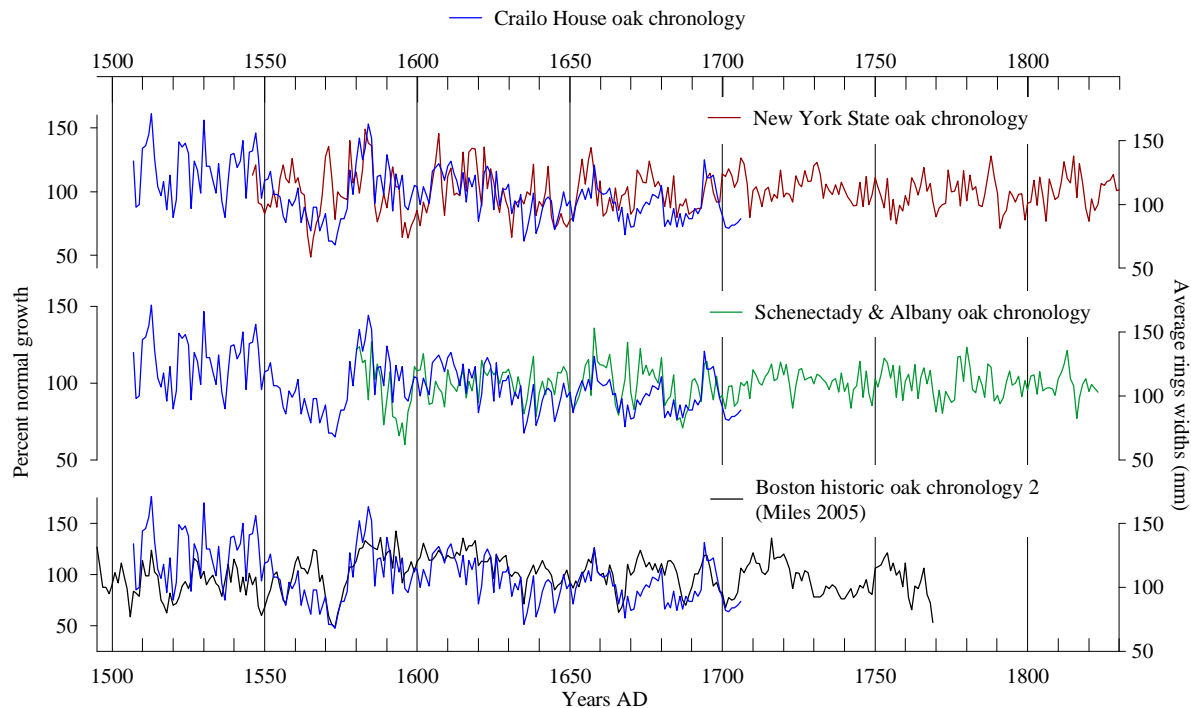
The oak chronology correlates significantly with established historic oak chronologies, telling us that the trees were cut down in 1707 (Figure 2), again in the late spring-early summer months.

Statistics for matching patterns:	Crailo vs NYS oaks	Crailo vs Schenectady oaks	Crailo vs Boston oaks	All are significant at the 0.05% level of probability
Student's <i>t</i> -score	5.74	8.40	8.02	
Pearson corr coeff	0.41	0.60	0.50	
Trend coeff	62%	75%	67%	
Overlap (years in common)	161	127	200

Figure 2. Shown here is the excellent visual and statistical crossdating between the Crailo oak chronology versus regional historic and modern oak chronologies, including the east-central and southeastern New York State chronology (top); the Albany-Schenectady historic oak chronology (middle) composed of tree-ring sequences in samples taken from other buildings, and a Boston historic oak chronology (Miles 2005).
