Dendrochronology of the Gregoire House, Carriage House, and Barn in Burdett, NY

Carol Griggs, Cornell Tree-Ring Laboratory
cbg4@cornell.edu

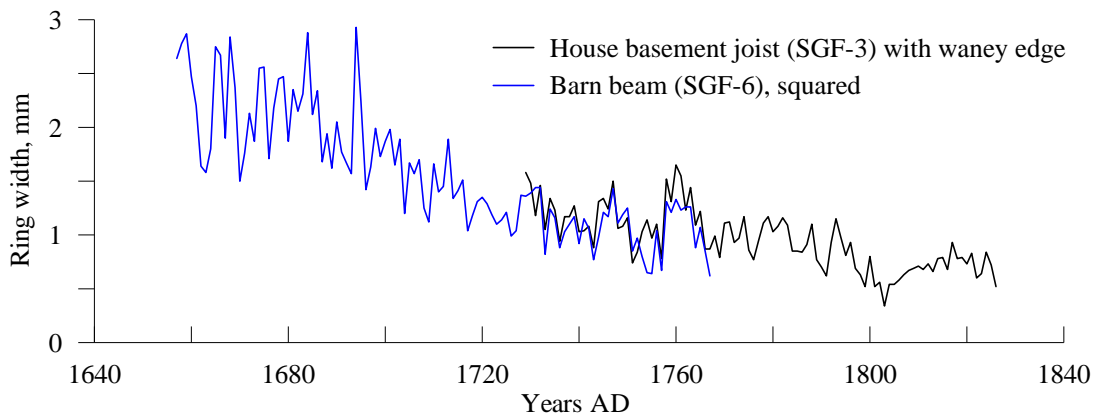
Figure 1. The similarity of the ring-widths in these two samples indicates that they most likely came from the same tree. The visual agreement is corroborated by the statistics.

between the patterns and ring widths in the big beam and the joist from the house basement clearly indicate that the two timbers came from the same tree (Figure 1). The wood in the large barn beam came from the center of a very big pine log. It appears that the outer slabs of that log, cut off in the squaring process, were sawn up and used for the joists in the original basement. That indicates that at least that part of the barn (south section) was built at the same time as the original part of the house, in 1827.

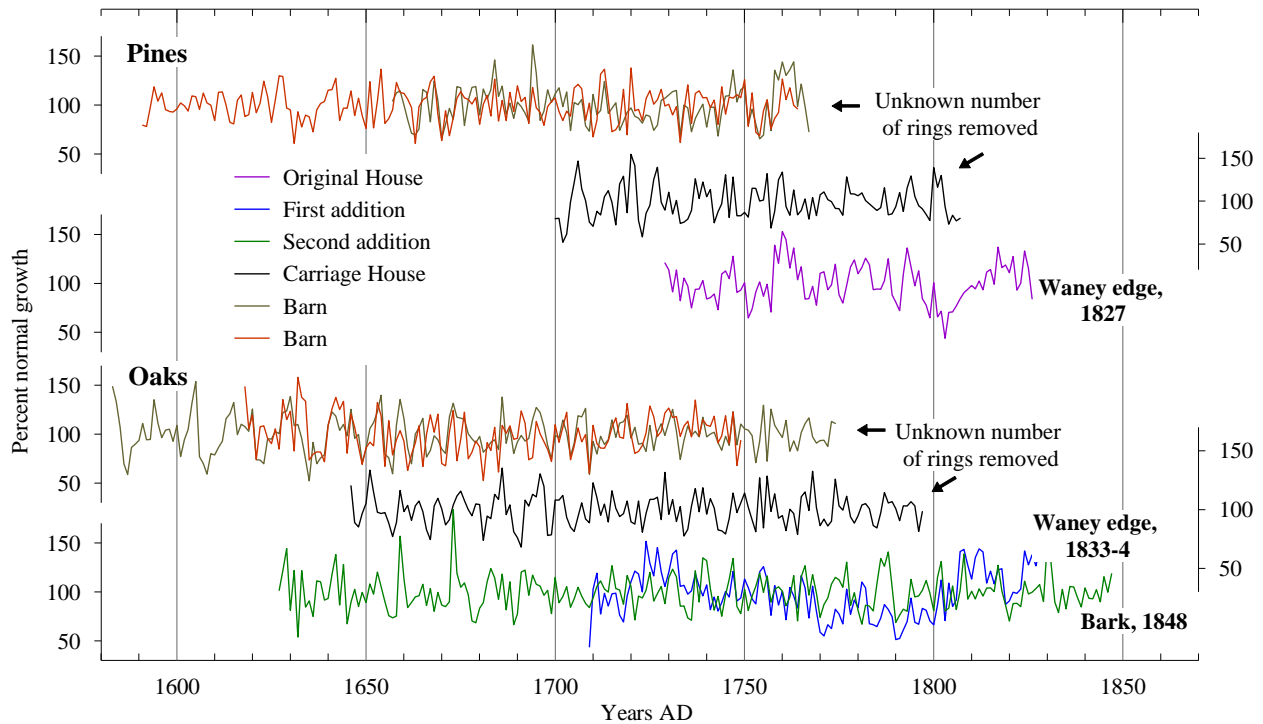
Figure 2. The ring width patterns of the samples are shown above: Top half of the graph are the pine samples; bottom half contains the oak patterns. The AD dates were assigned only after we looked at the similarities in patterns with the regional chronologies (Figure 3).

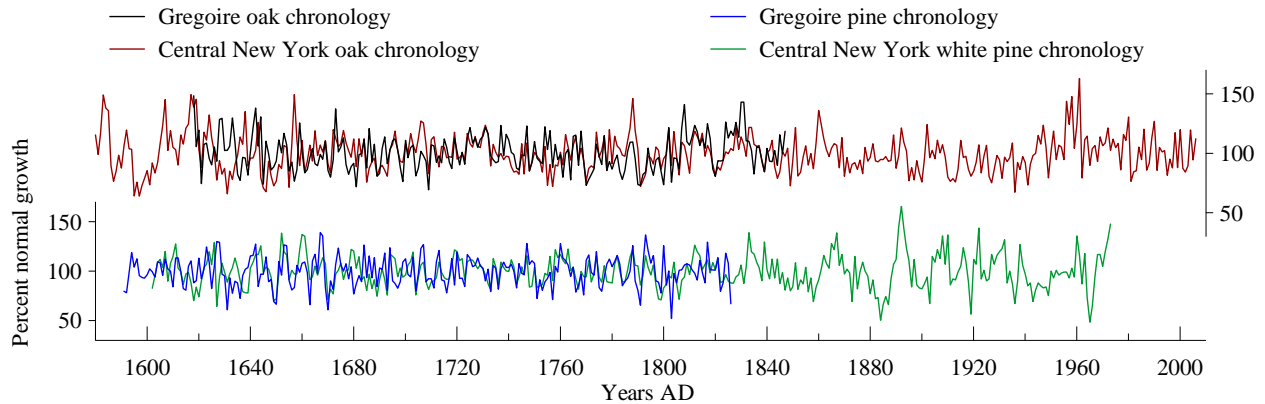
Figure 3. The two chronologies are her compared to our regional chronologies of the same genus or species. The statistical tests are all statistically significant, and the visual similarity indicates that the dates are secure.

From a dendrochronological perspective, the samples from this site are a very nice example of primary forest growth, with their origins dating before the European settlement of this region. The range of ring count goes from 98 to 221, and ring widths from 0.33 to 4.5 mm. From the detrended ring-widths of the 9 samples, two chronologies were constructed, one of the 4 pine samples, the other of the 5 oak samples, and both are over 230 years long (Figure 2). The oak chronology ends in 1847 (the outer 1848 ring in the two samples is partial, so there is no measurement for that year), and the pine chronology in 1826 (partial ring in 1827) and their constituents are listed in the Appendix and shown in Figure 2. The two chronologies are shown in Figure 3, compared to the regional pine and oak chronologies that were used to place these

sequences in time. The closeness of their ring-width patterns indicates how the dates were determined. Our two regional chronologies consist of forest and historic samples from around central New York. The collections closest to this site came from Burdett, Ithaca, and Corning for the pines; and from Cayutaville, Ithaca, Corning, and Phelps for the oaks.
